HIDDEN VALLEY LAKE DAM
MERCER COUNTY, MISSOURI
MO 10665

PHASE 1 INSPECTION REPORT
NATIONAL DAM SAFETY PROGRAM

PREPARED BY: HOSKINS-WESTERN-SONDEREGGER, INC.
FOR: STATE OF MISSOURI

JULY, 1978

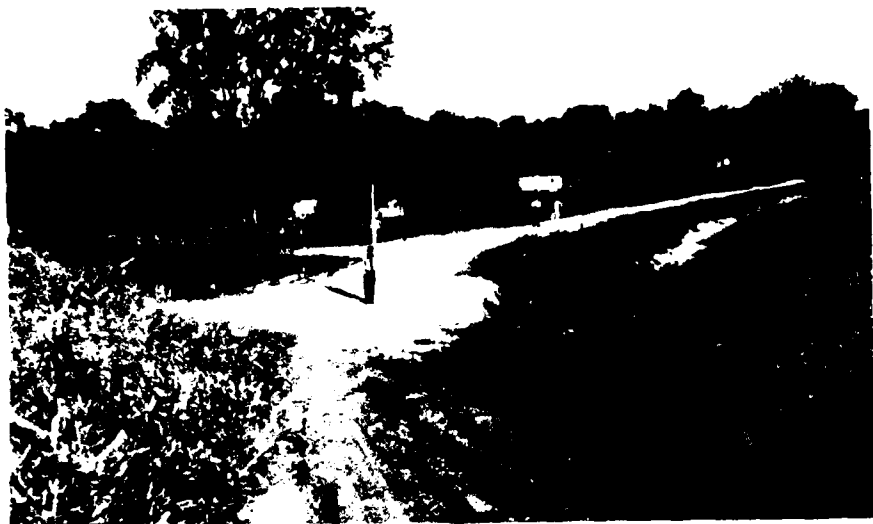
The emergency spillway consists of a parabolic channel cut into the left abutment. At the center line of the dam, the spillway has a maximum width of 75 feet \pm and a maximum depth of 1.8 feet \pm below the elevation of the top of the dam. There is no defined inlet or forebay section. The parabolic section extends about 15 feet upstream from the $\frac{1}{2}$ of the dam and about 25 feet downstream from $\frac{1}{2}$ of dam. The bottom 30 feet \pm of this section has been plated with loose limestone rock to a depth of 1 to 1.5 feet. (This was reportedly done this spring.) The outlet channel downstream from the plated section was badly eroded. The bottom of the gully was 10 to 12 feet wide and the side slopes were nearly vertical. A series of four woven wire check dams had been constructed in the gully. The last or fourth check dam was approximately 55 feet downstream from the rock plated section. A deep narrow gully extended downstream from the last wire check dam.

PHOTO. NO. 2
SPILLWAY AND
DAM FROM SOUTH-
EAST END. ROD
IN CONTROL SEC-
TION OF SPILLWAY.

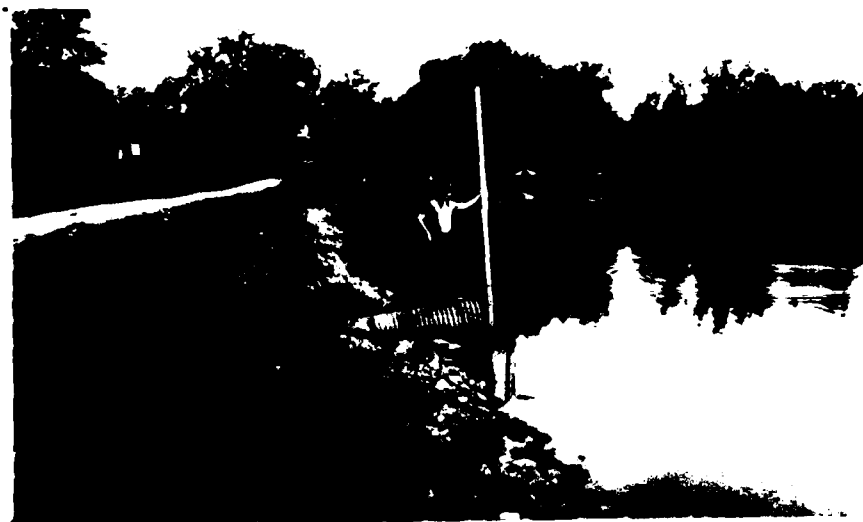
e. Downstream Channel. Spillway discharge flows through a badly eroded gully. The channel downstream from the primary spillway channel is overgrown with trees and brush.

PHOTO. NO. 6
LOOKING NORTH-
WEST. PIPE
SPILLWAY IN
CENTER.
